# An Assessment of the Quality of Six Intersections in Omaha

Craig Moody's Passion Project for Verdis Group, LLC

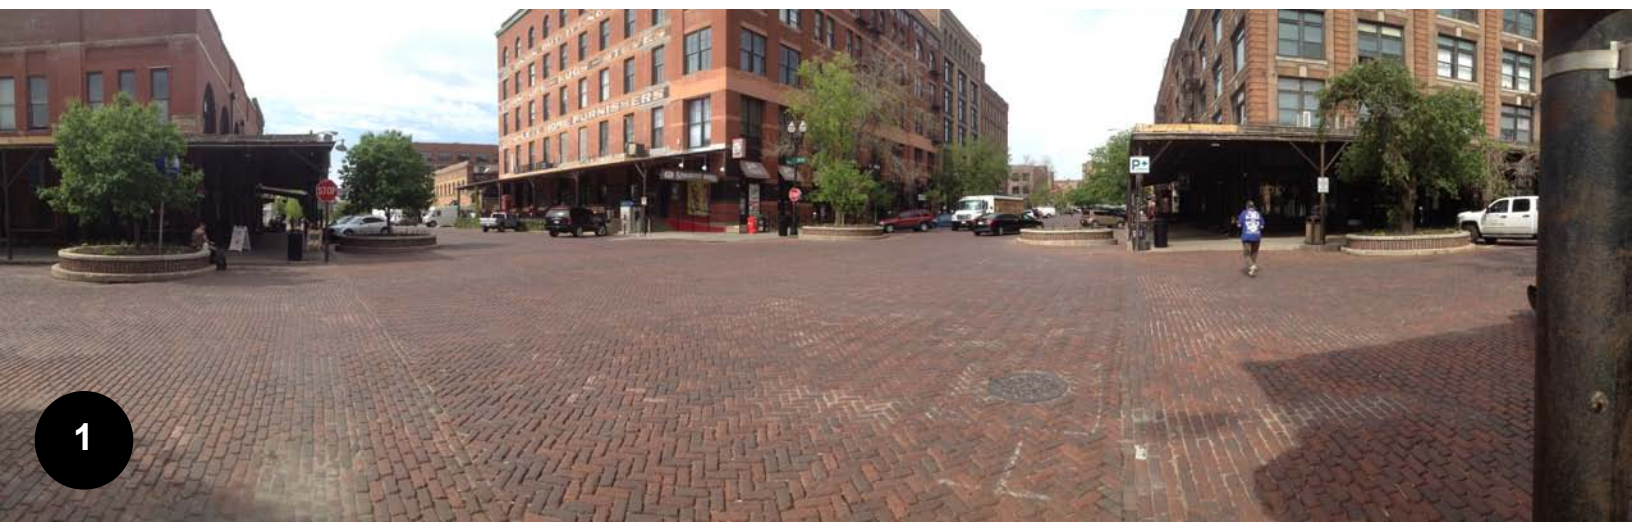
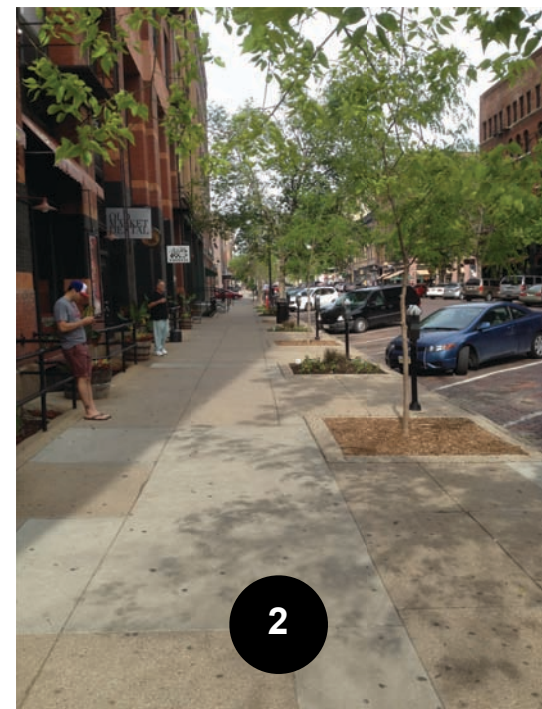
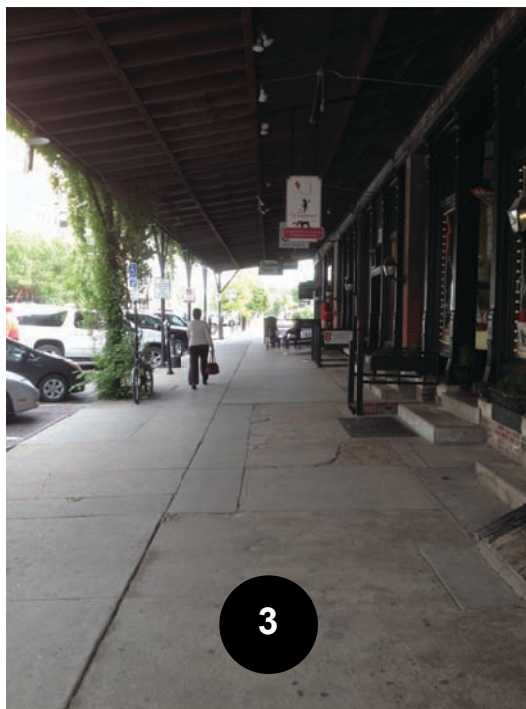
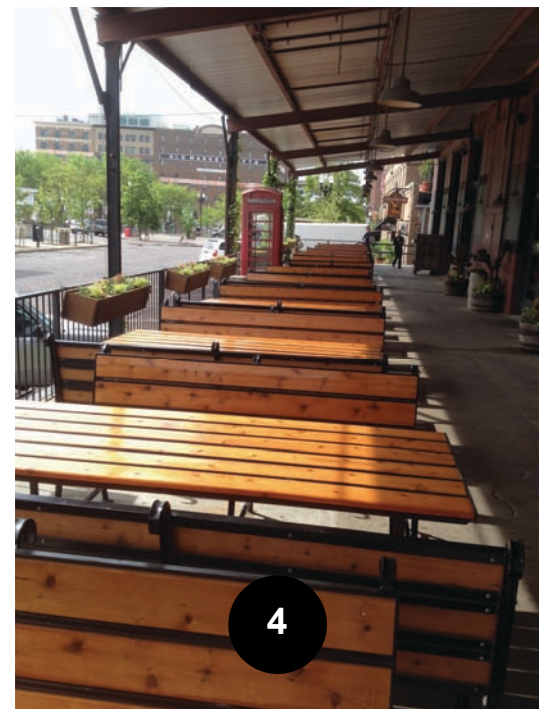
# 1. 11th & Howard

(1) One of Omaha's more iconic intersections with brick pavers and tree planters on corners that allow for sitting, lingering, gawking, and strumming a guitar. (2) Wide sidewalks on the SW corner boast good tree canopy. (3) Most sections have great overhangs that give Old Market patrons an improved sense of place. (4) The picnic table-style seating outside of Spaghetti Works provides a unique place to enjoy a plate of pasta and the Old Market's many activities.

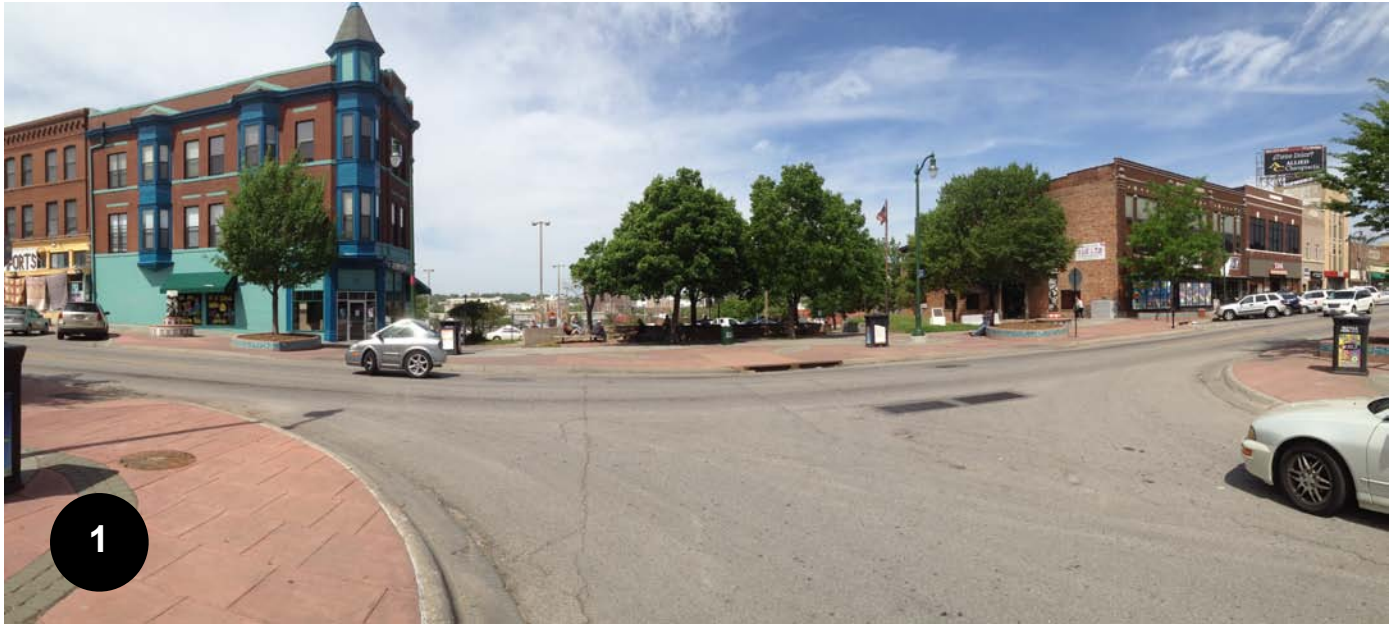
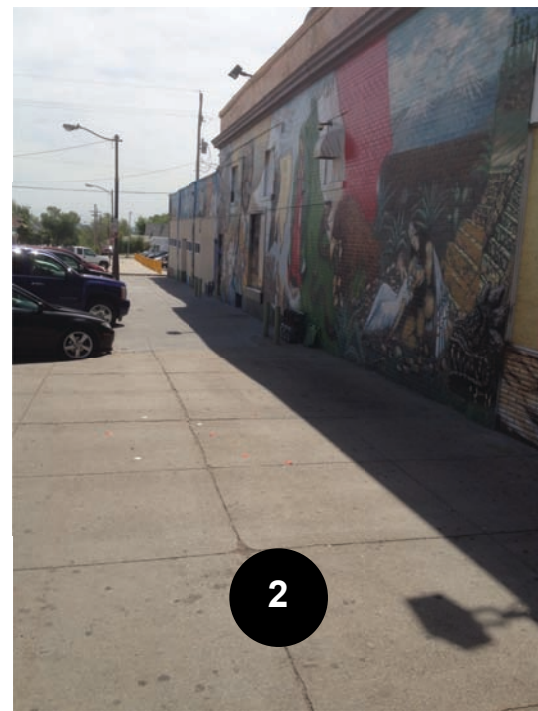
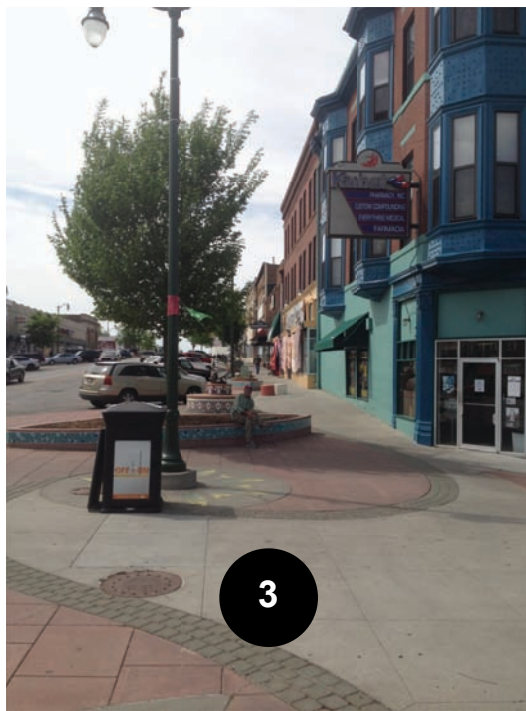
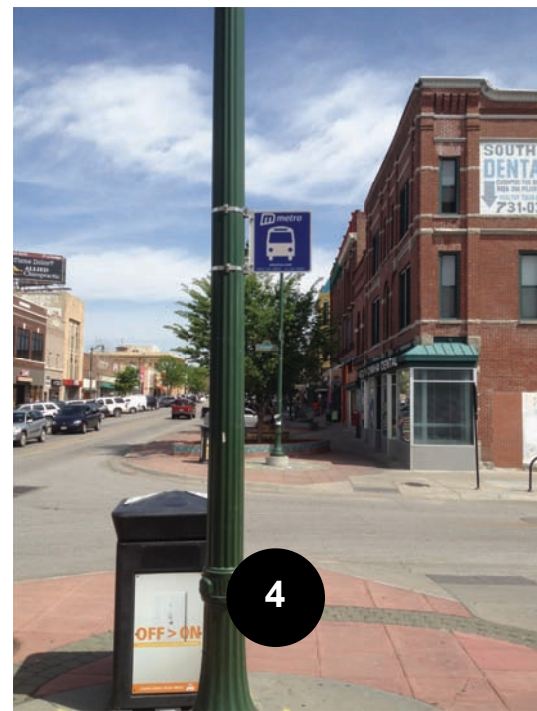
## 2. 24<sup>th</sup> & N

(1) The 3-way intersection with public space on the west provides an excellent gathering spot for lingering, nibbling helado, playing chess, and enjoying good conversation. (2) A mural on the SE corner of the intersection. (3) Unique public seating, planters, and sidewalk treatments give the area a look and feel all its own. (4) Standard issue bus stop with a sign on a pole, although ample public seating nearby provides a place of respite for transit users.

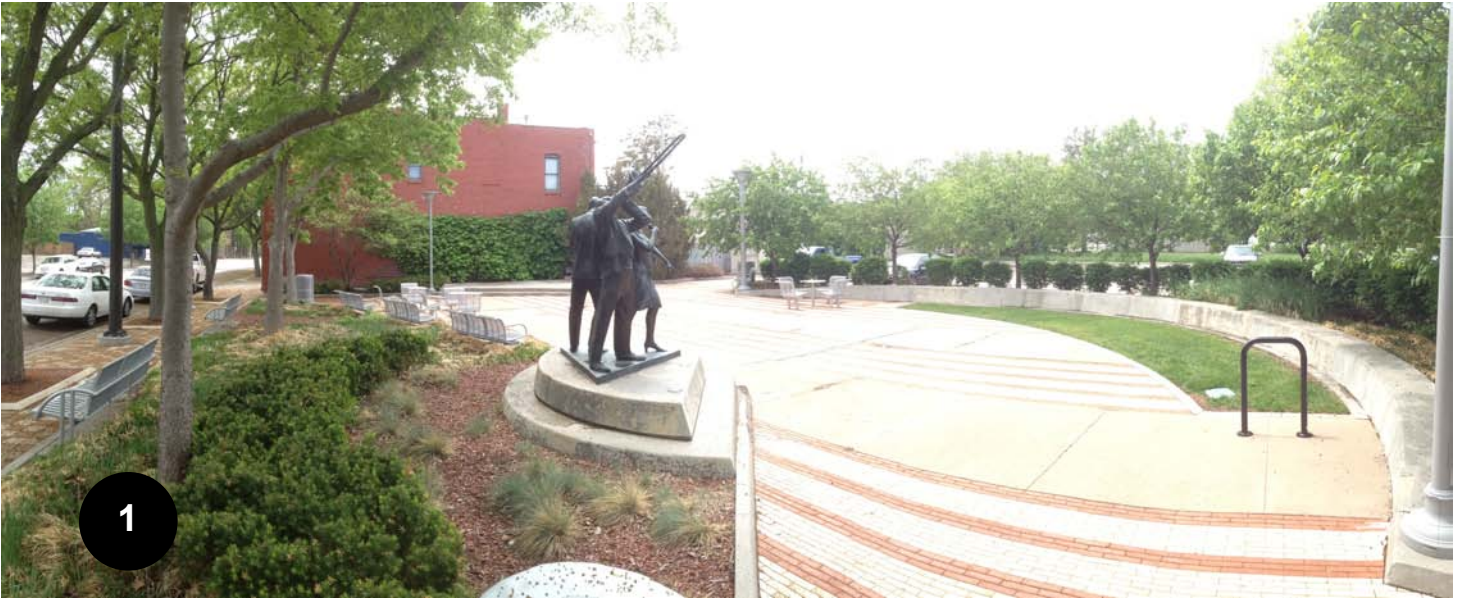
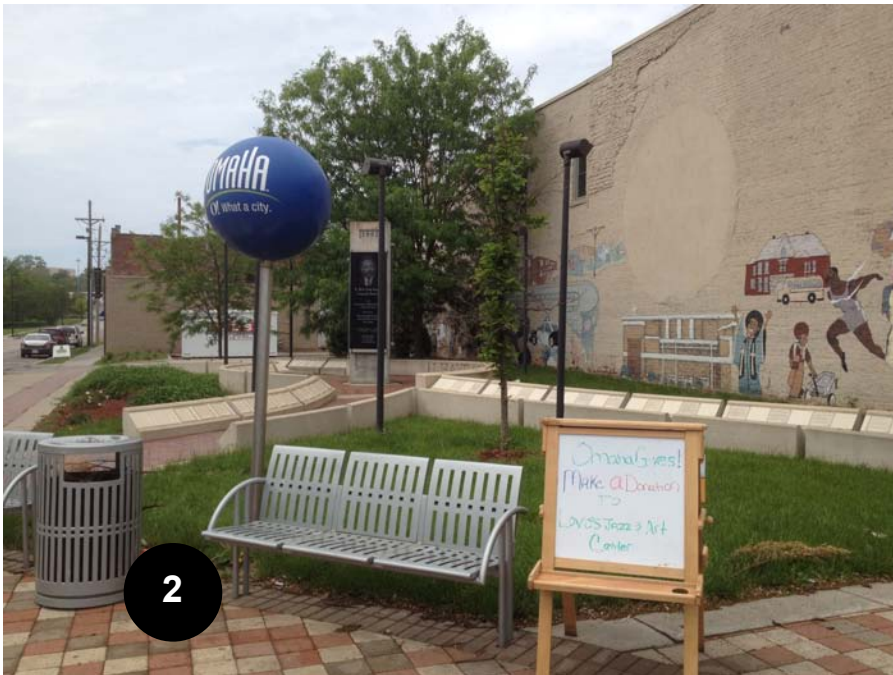
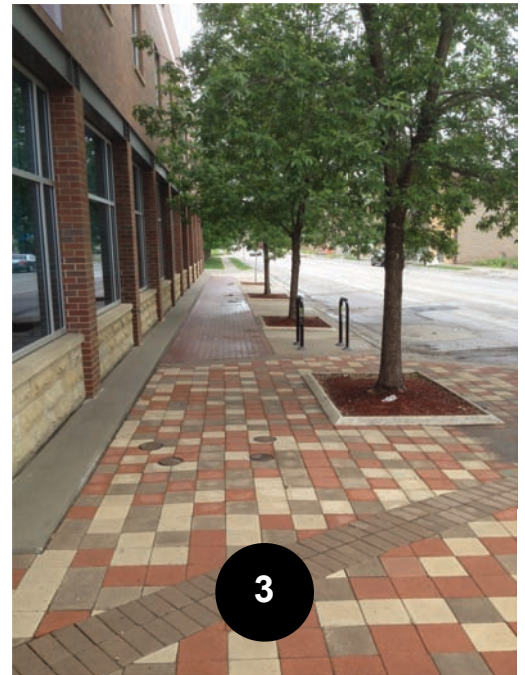
# 3. 24<sup>th</sup> & Lake

(1) One of Omaha's best pocket parks sits just SW of the 24th & Lake intersection and includes great art, bike racks, and a performance stage (the public art honors the jazz history of the area). (2) Public seating, educational public art, a small green space, and an announcement board activate the NW corner. (3) Streetscape enhancements a few years ago provide interesting context, bike racks await a visitor, and excellent street trees create an overall exceptional environment.

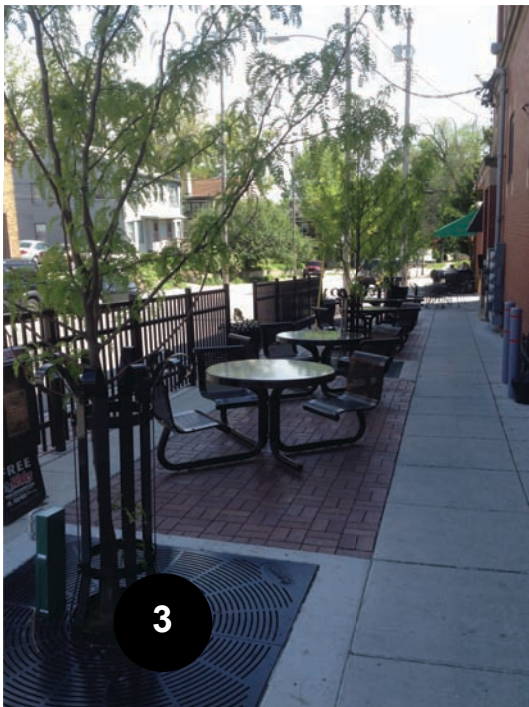
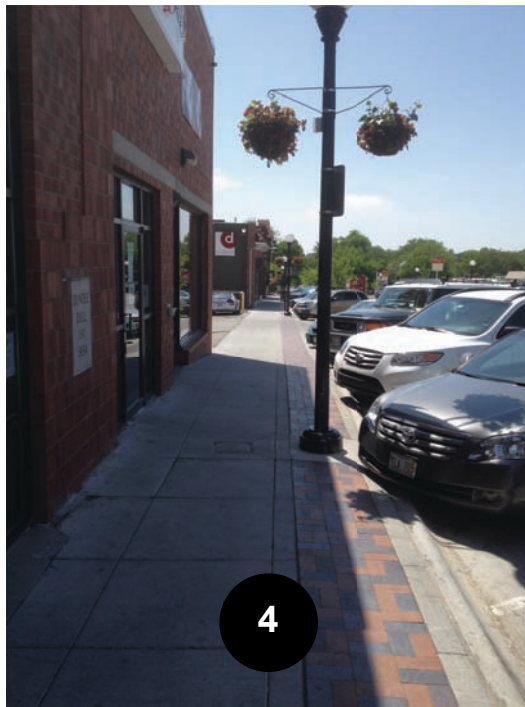
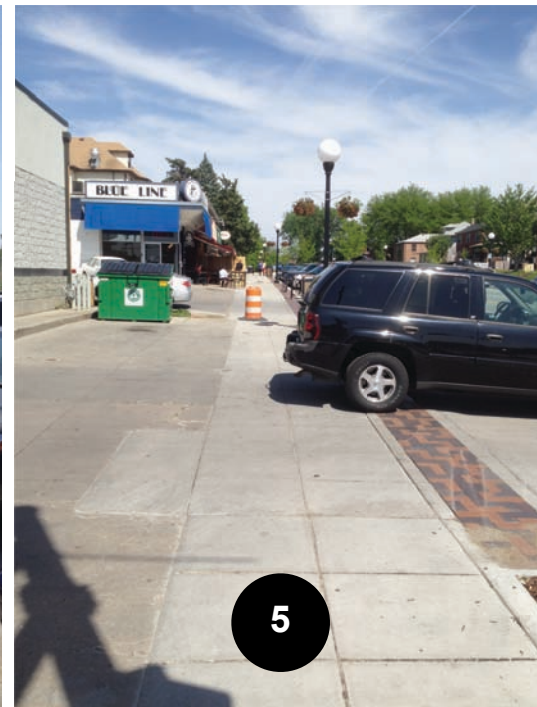
# 4. 50<sup>th</sup> & Underwood

(1) A recent \$2+ million streetscape project produced this public seating area and bike racks. (2) There are several restaurant patios throughout the intersection. (3) A new seating area on the SW corner includes a nice fence that provides protection for ice cream or falafel eaters from motorists. (4) In many cases, the streetscape work did not result in much larger sidewalks, which limits opportunities for random lingering. (5) A gas station on the NE corner creates often dangerous interactions between motorists and pedestrians.

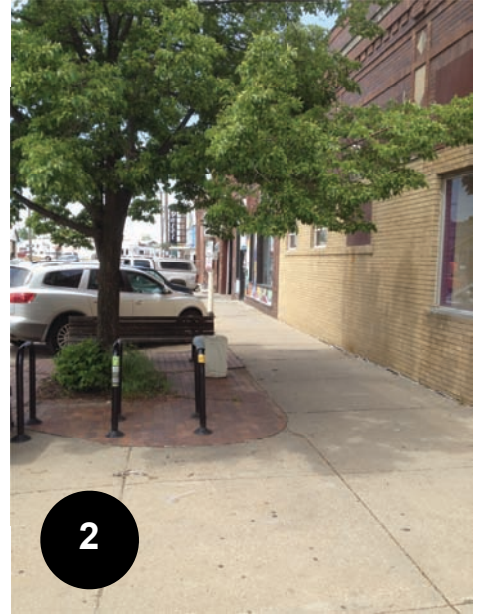
# 5. 64<sup>th</sup> & Maple

(1) Maple Street is designated as a Nebraska State Highway, which inhibits good pedestrian-friendly design and results in unfortunate truck traffic. (2) The only true public seating was a lone bench discreetly tucked under an enjoyable tree. (3) Sidewalks along Maple are narrow and in disrepair, as are (4) those on 64th Street. Landscaping is less than inspiring. (5) Bikes and fortunately bike racks are quite prevalent in Benson despite limited space.

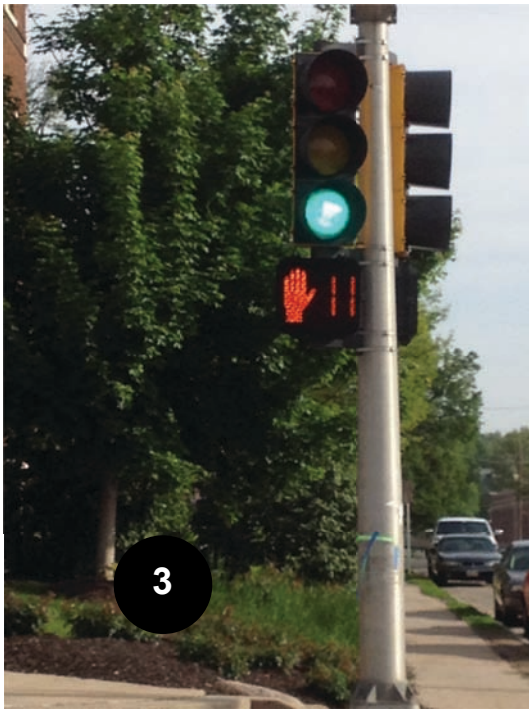
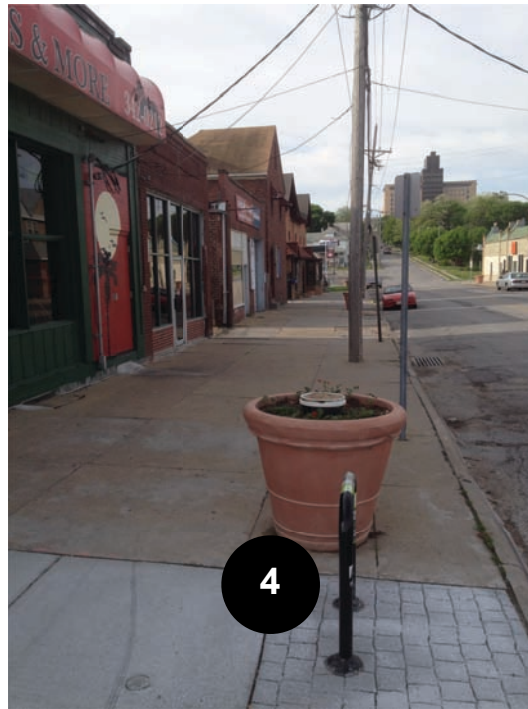
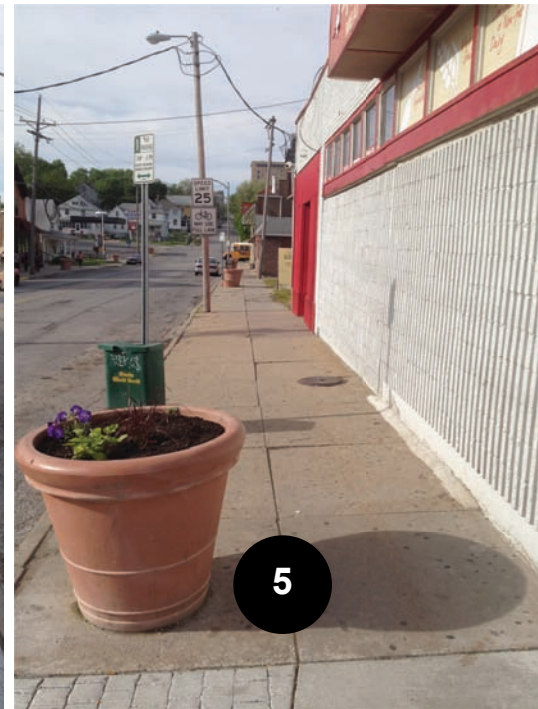
## 6. 33<sup>rd</sup> & California

(1) The intersection is anchored by an historic apartment complex on the NW corner. (2) The only intersection studied that includes any on-street markings for bicyclists; in this case, sharrows. (3) The crosswalk signal was malfunctioning at the time of my visit; a local merchant and I discussed and phoned the Mayor's Hotline. (4 & 5) Sidewalks along 33rd to the south are in average condition but, aside from a few planters and a lonely bike rack, don't have any more desirable amenities such as public seating.
