# An Assessment of the Quality of Six Intersections in Omaha

Craig Moody's Passion Project for Verdis Group, LLC

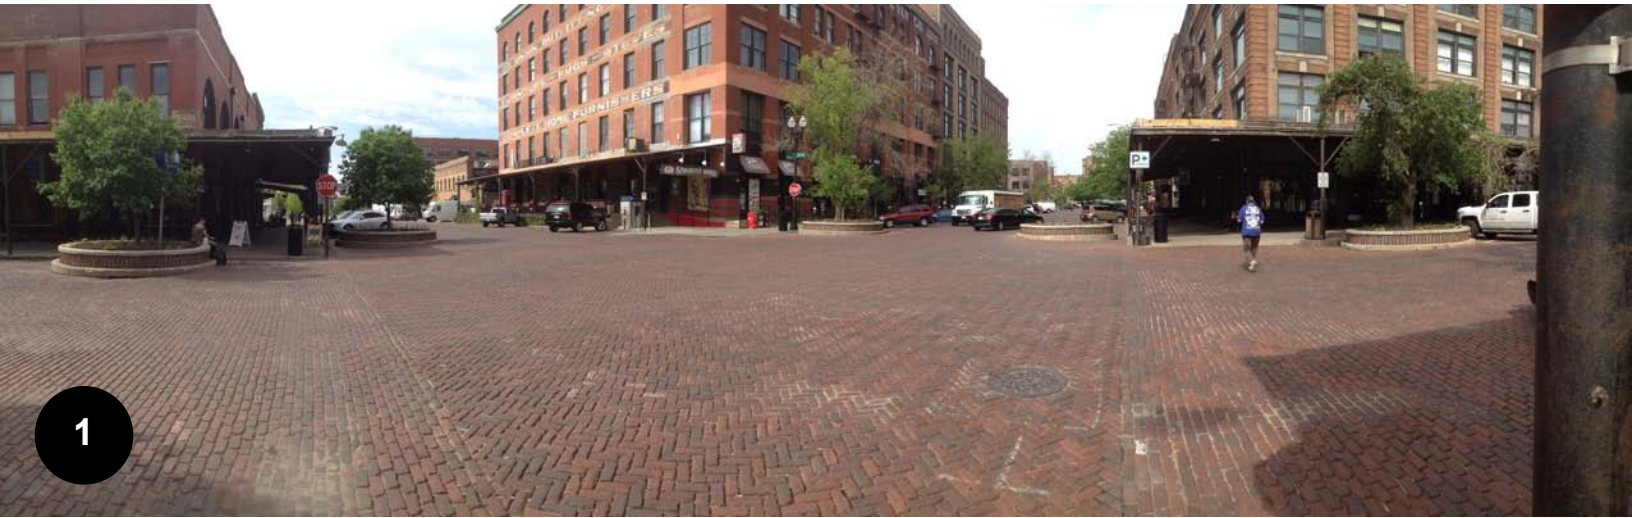
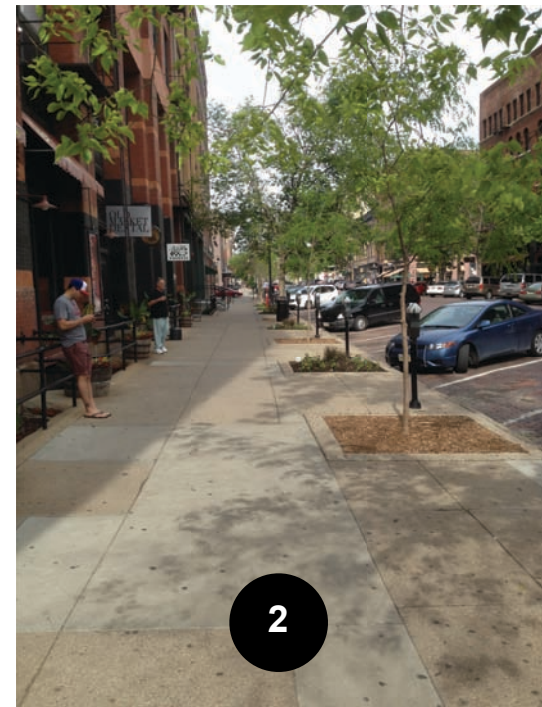
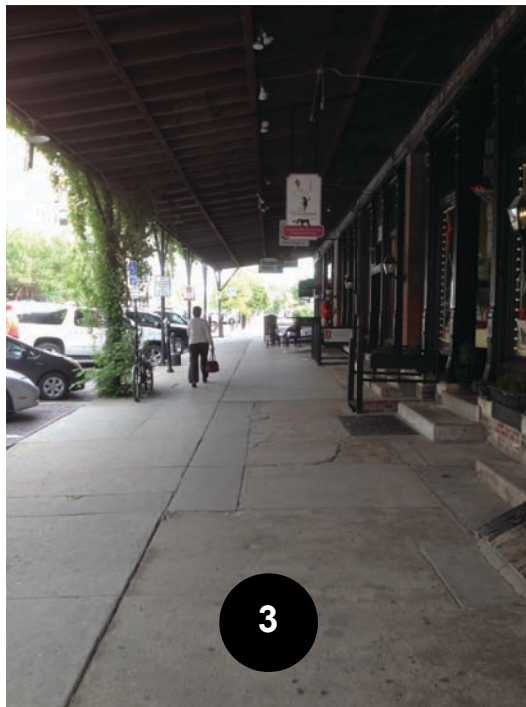
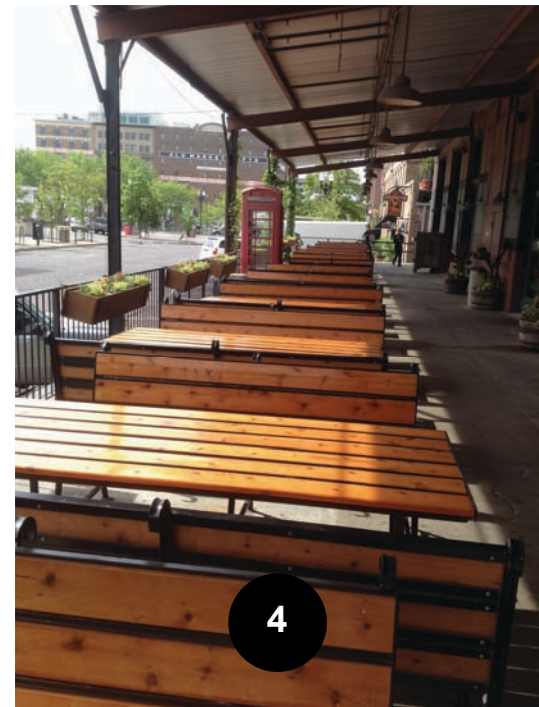
# 1. 11th & Howard

- Travel lanes were still on the wider side (12' - 13')
- It's a bit of a bumpy ride for a cyclist, which is unavoidable given the cobblestone
- Street vendors were not present at the time observation occurred (10am); this changes dramatically during later hours of the day and on weekends
- No curb ramps
- Limited (if not entirely nonexistent) recycling

(1) One of Omaha's more iconic intersections with brick pavers and tree planters on corners that allow for sitting, lingering, gawking, and strumming a guitar. (2) Wide sidewalks on the SW corner boast good tree canopy. (3) Most sections have great overhangs that give Old Market patrons an improved sense of place. (4) The picnic table-style seating outside of Spaghetti Works provides a unique place to enjoy a plate of pasta and the Old Market's many activities.

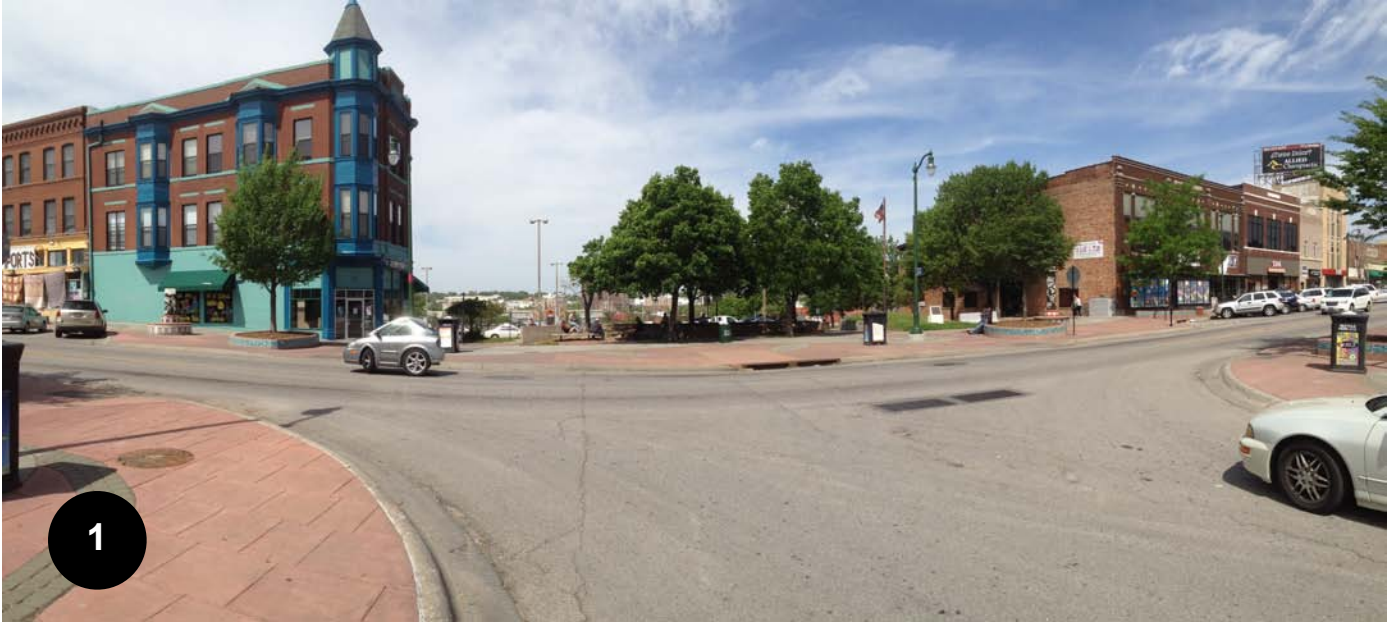
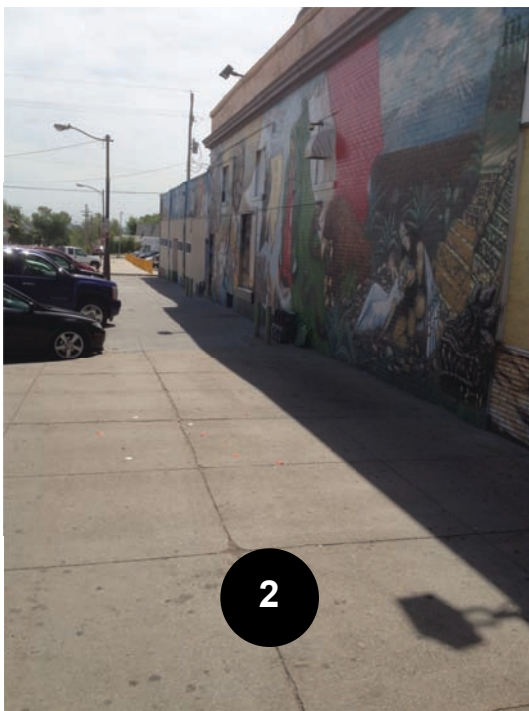
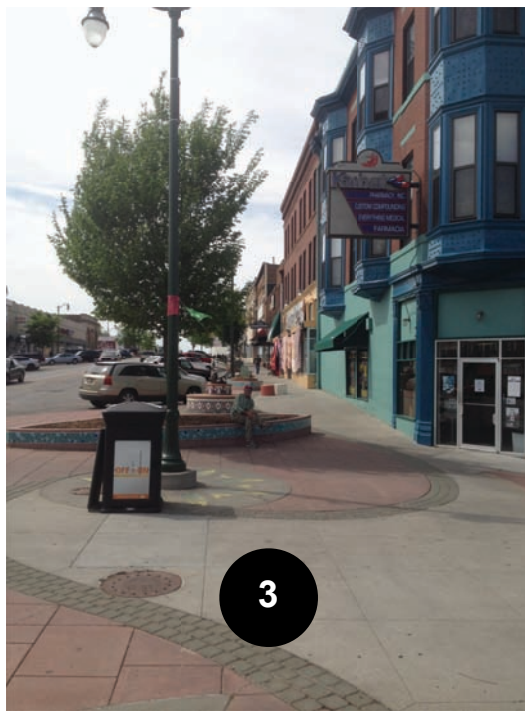
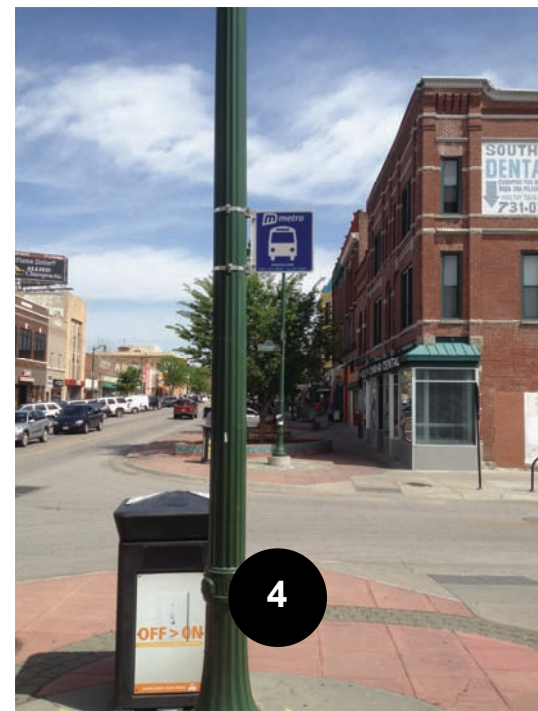
## 2. 24<sup>th</sup> & N

- On-street bike facilities don't exist
- Travel lanes were wide (12' - 13')
- Pedestrian crossings were not marked
- No parking meters (but signs indicated 1 and 2 hour parking limits)
- Building transparency was extremely limited despite the existence of windows (many were painted on or generally covered with other materials)
- No outdoor restaurant seating
- General cleanliness was substandard

(1) The 3-way intersection with public space on the west provides an excellent gathering spot for lingering, nibbling helado, playing chess, and enjoying good conversation. (2) A mural on the SE corner of the intersection. (3) Unique public seating, planters, and sidewalk treatments give the area a look and feel all its own. (4) Standard issue bus stop with a sign on a pole, although ample public seating nearby provides a place of respite for transit users.

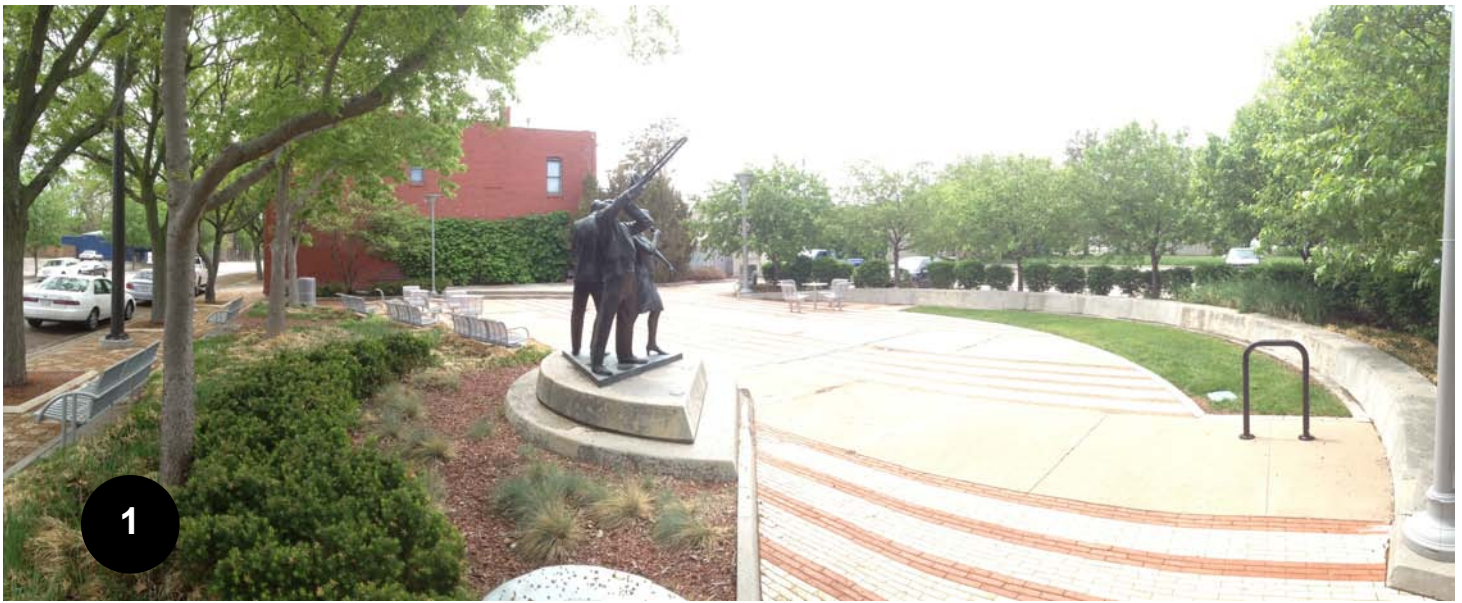
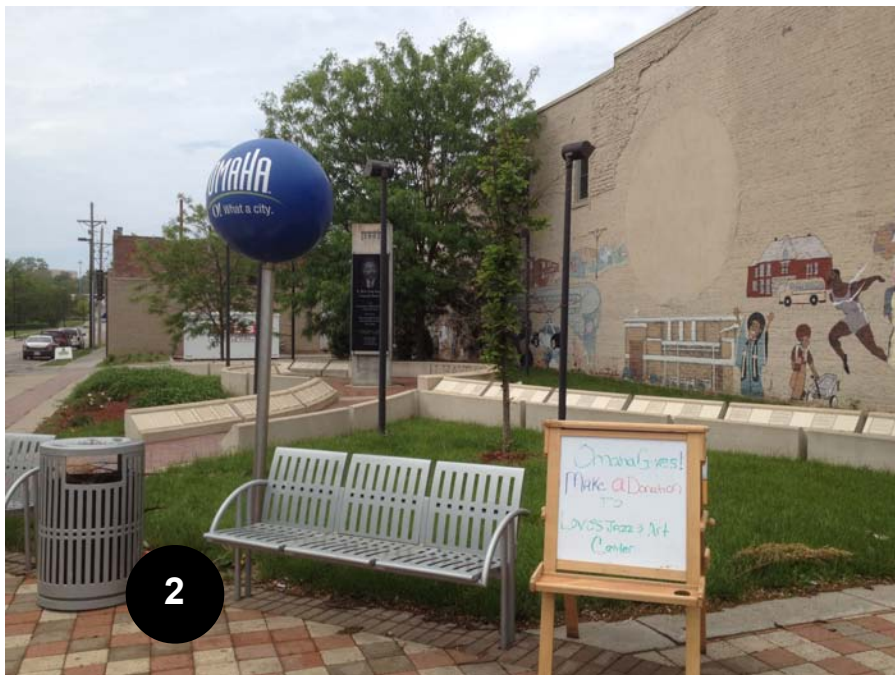
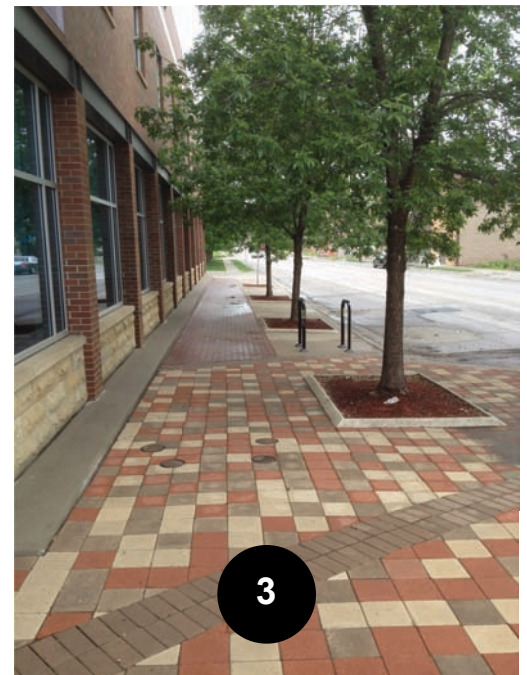
# 3. 24<sup>th</sup> & Lake

- No on street bicycle infrastructure
- Travel lanes wider than necessary (13')
- Stoplight for traffic control
- No parking meters (but signs indicated 1 and 2 hour parking limits)
- Virtually no pedestrian activity or street vendors during the time of observation (possibly a function of the time of day (10:30am))
- Building space types were primarily homogenous on each corner (office, retail, parking)
- Building transparency was limited despite windows in most buildings (shades were drawn, windows painted over)
- No private (restaurant) outdoor seating

(1) One of Omaha's best pocket parks sits just SW of the 24th & Lake intersection and includes great art, bike racks, and a performance stage (the public art honors the jazz history of the area). (2) Public seating, educational public art, a small green space, and an announcement board activate the NW corner. (3) Streetscape enhancements a few years ago provide interesting context, bike racks await a visitor, and excellent street trees create an overall exceptional environment.

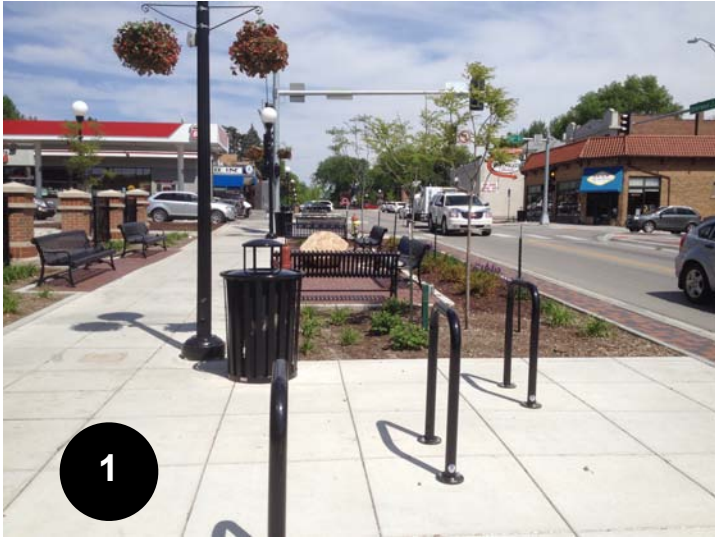
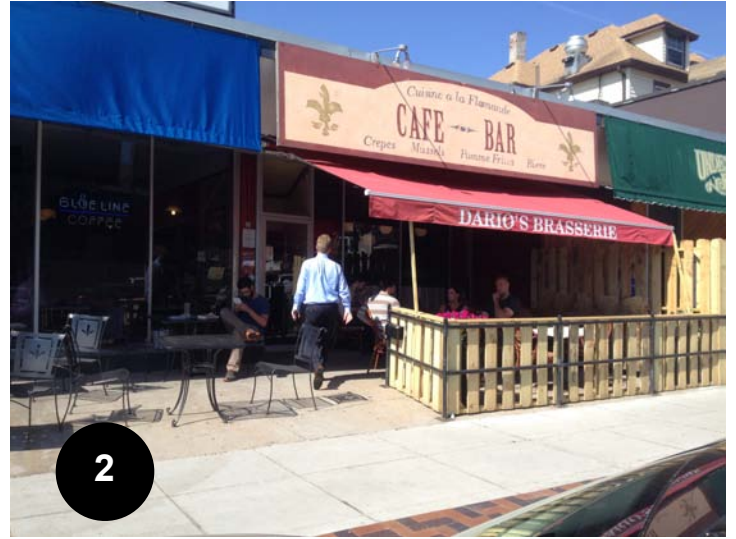
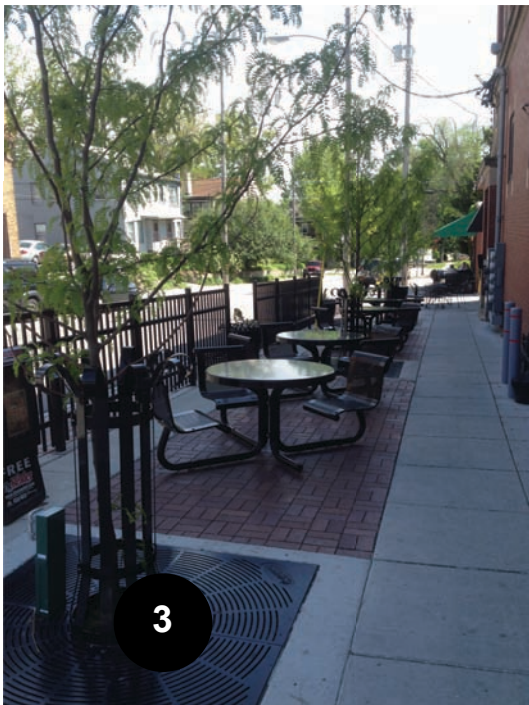
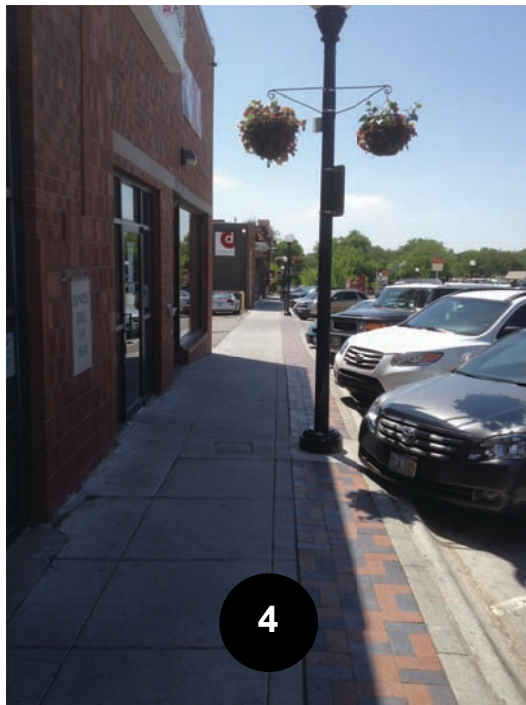
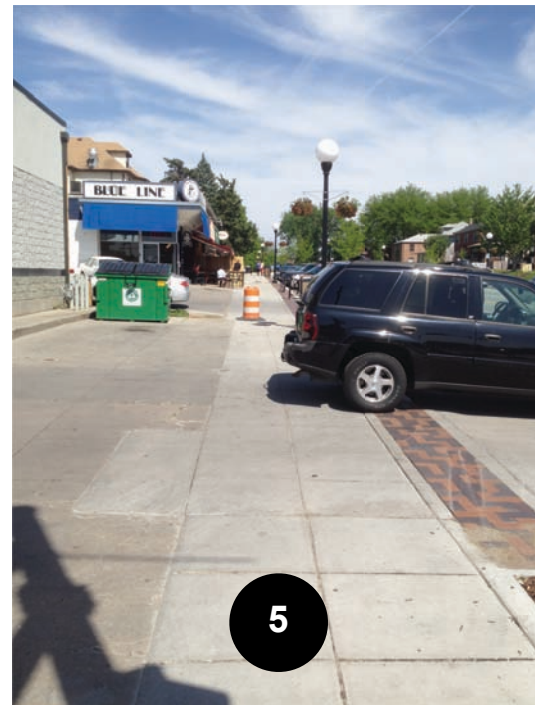
# 4. 50<sup>th</sup> & Underwood

- No on street bicycle infrastructure
- Wide travel lanes (12')
- Stoplight traffic control
- Driveways through pedestrian ROW are dangerous, especially around the gas station
- No parking meters
- Very immature tree canopy (a result of all trees being removed for the streetscape work)
- No street vendors
- Building heights were all primarily one story

(1) A recent \$2+ million streetscape project produced this public seating area and bike racks. (2) There are several restaurant patios throughout the intersection. (3) A new seating area on the SW corner includes a nice fence that provides protection for ice cream or falafel eaters from motorists. (4) In many cases, the streetscape work did not result in much larger sidewalks, which limits opportunities for random lingering. (5) A gas station on the NE corner creates often dangerous interactions between motorists and pedestrians.

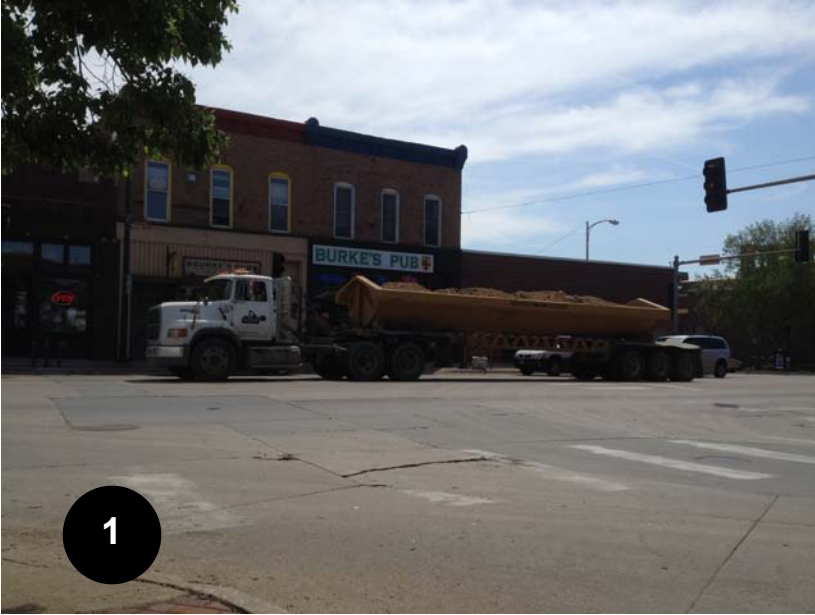
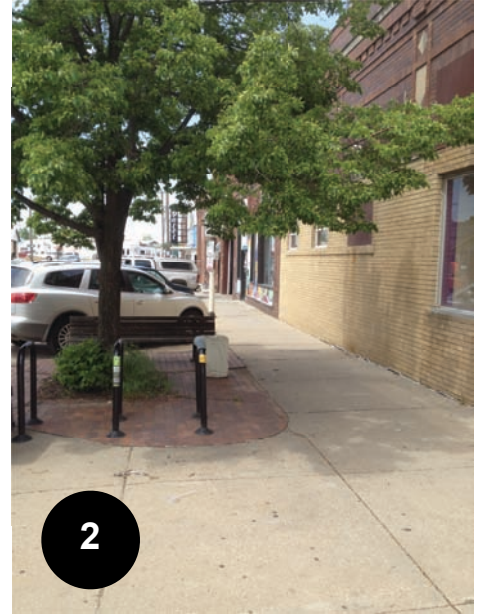
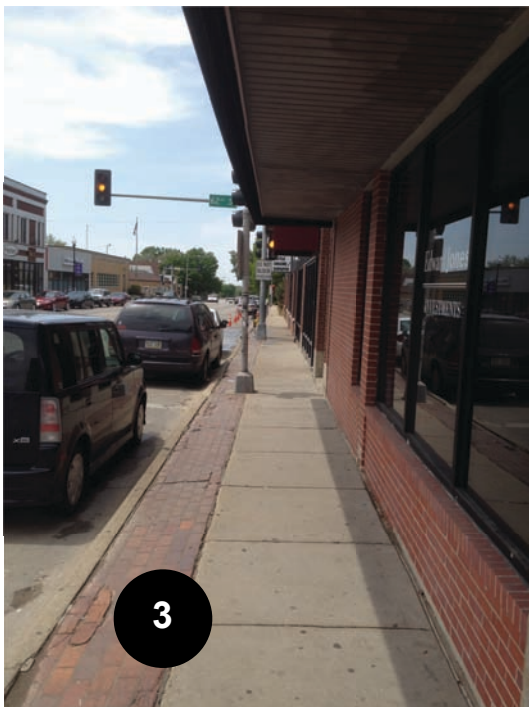
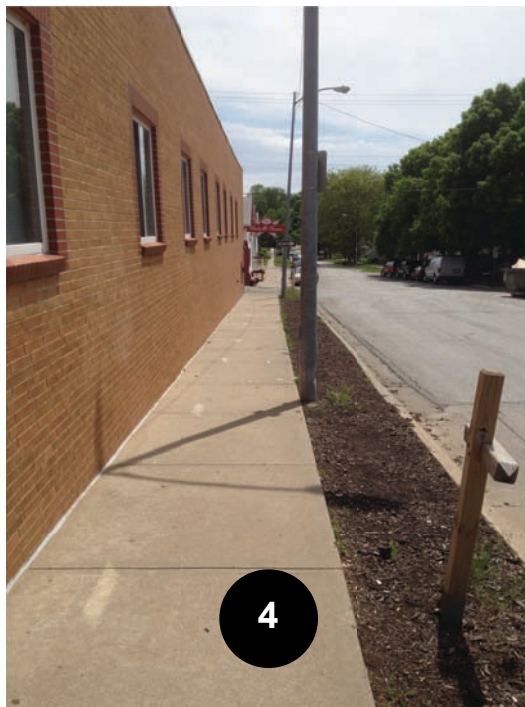
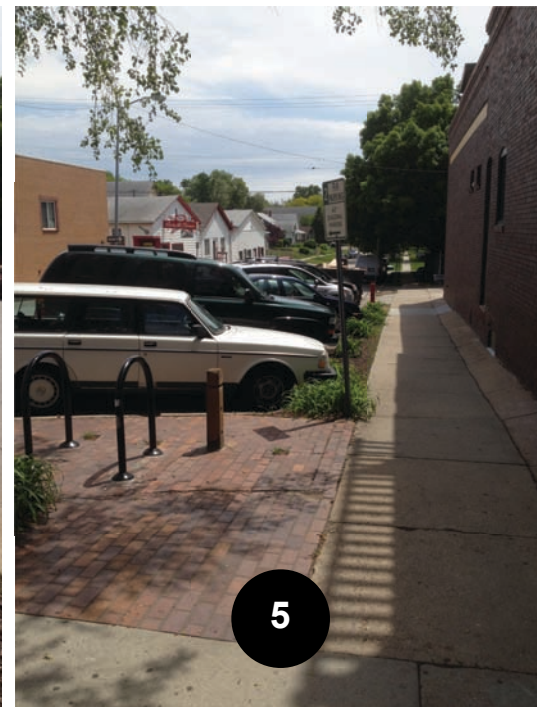
# 5. 64<sup>th</sup> & Maple

- Sidewalks were narrow and crumbling in several cases (soon to be resolved)
- Truck traffic made the area pretty unenjoyable. Maple is also State Highway 64.
- Street furniture was limited
- Bike infrastructure (other than parking) was nonexistent
- The tree canopy and other landscaping was pretty limited
- There was no outdoor seating (sidewalks are too narrow to allow as much)
- Litter was fairly common

(1) Maple Street is designated as a Nebraska State Highway, which inhibits good pedestrian-friendly design and results in unfortunate truck traffic. (2) The only true public seating was a lone bench discreetly tucked under an enjoyable tree. (3) Sidewalks along Maple are narrow and in disrepair, as are (4) those on 64th Street. Landscaping is less than inspiring. (5) Bikes and fortunately bike racks are quite prevalent in Benson despite limited space.

All in all, Benson is succeeding despite the challenging streetscape design and infrastructure. The upcoming streetscape enhancement will address many of these issues and improve the area dramatically.

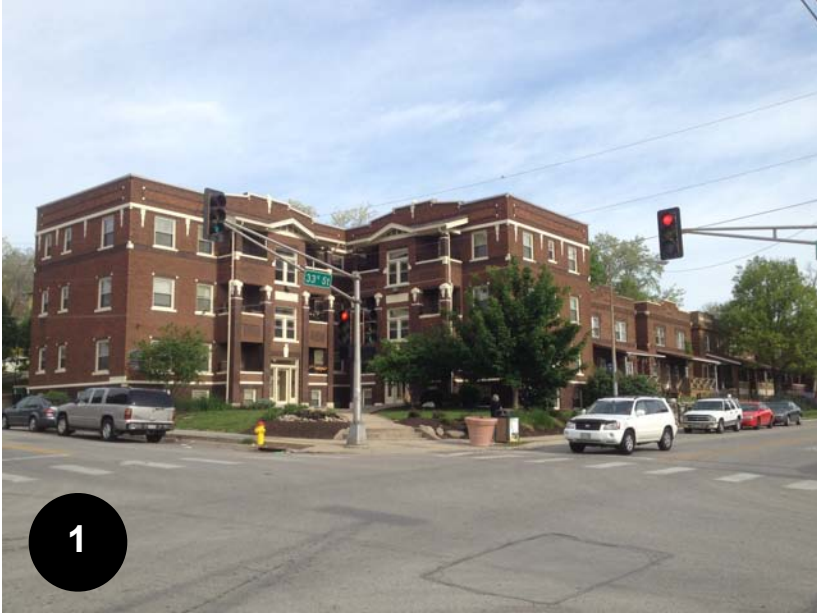
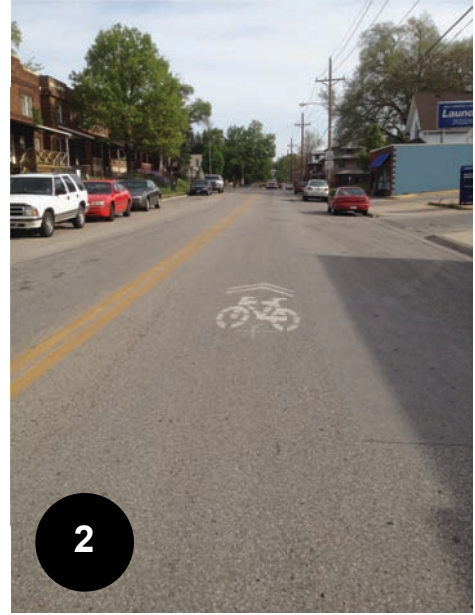
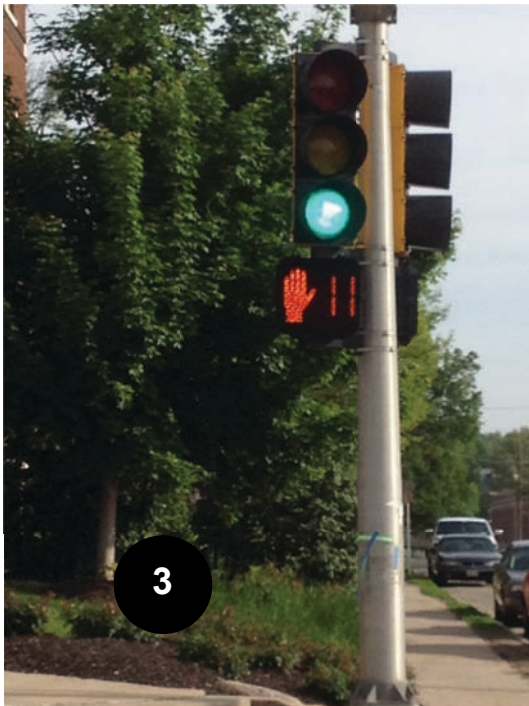
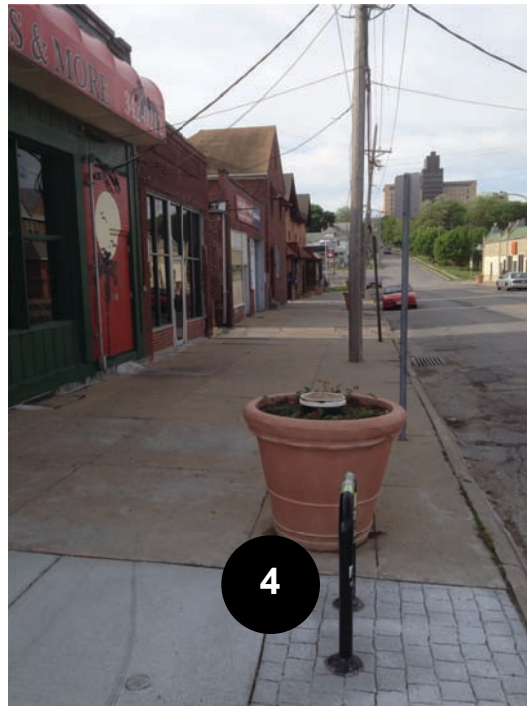
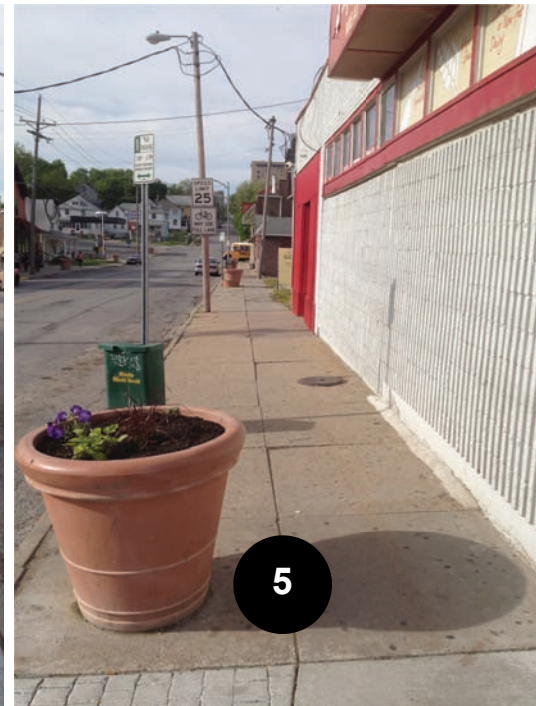
## 6. 33<sup>rd</sup> & California

- The tree canopy was mostly nonexistent
- Travel lane widths varied but were generally on the wide side (9' - 13'6")
- Stoplight traffic control with malfunctioning walk signals
- No street furniture
- Planters with no plants and generally no other landscaping except for that in front of the Melrose Apartments
- No bump outs at intersections
- Building transparencies were mostly poor
- Old and ugly trash containers (no recycling)
- No parking meters
- No street vendors
- No bar/restaurant outdoor seating

(1) The intersection is anchored by an historic apartment complex on the NW corner. (2) The only intersection studied that includes any on-street markings for bicyclists; in this case, sharrows. (3) The crosswalk signal was malfunctioning at the time of my visit; a local merchant and I discussed and phoned the Mayor's Hotline. (4 & 5) Sidewalks along 33rd to the south are in average condition but, aside from a few planters and a lonely bike rack, don't have any more desirable amenities such as public seating.

It's currently not a very inviting area, although it has potential to dramatically improve through increased outdoor seating, trees, and landscaping. There is plenty of sidewalk space that could be used more intentionally to create a better environment.
